EXPERT REPORT IN SUPPORT  
OF HONEYWELL DEFENSE  
REGARDING THE TPE331-10R-511C  
TURBOPROP ENGINE, SERIAL NUMBER P42145C,  
INSTALLED ON DE HAVILLAND  
DHC-3 OTTER  
REGISTRATION N93PC  
INVOLVED IN CRASH  
NEAR SOLDOTNA, AK ON JULY 7, 2013

HONEYWELL AEROSPACE  
PHOENIX, ARIZONA  
SEPTEMBER 29, 2017

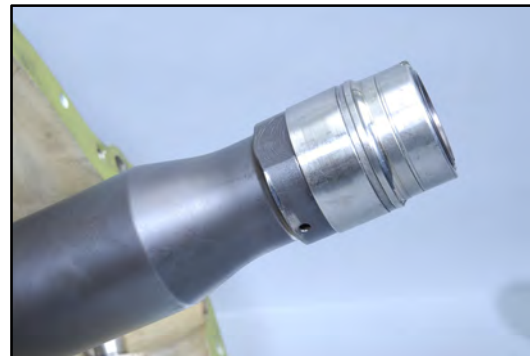
**Figure 6. Propeller Shaft**

- Rotational scoring to the propeller shaft (Figure 5 & Figure 6) with corresponding rotational scoring to the inner bore of the sun gear (Figure 7 & Figure 8).

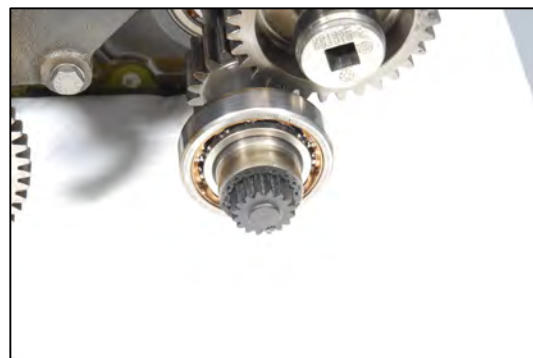
**Figure 9. Starter/Generator  
Drive Shaft**

- The separated starter/generator drive splines remained within the gear splines (Figure 9), (the separation is consistent with the sudden stoppage of the propeller).

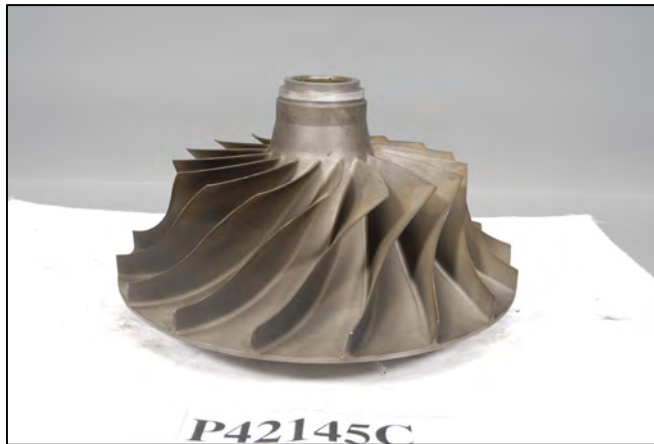
**Figure 13. First Stage Compressor Impeller**

- Rotational scoring damage (rub) was noted to the first stage compressor impeller shroud inducer and exducer areas (Figure 12) with corresponding scoring to the first stage compressor impeller (Figure 13 & Figure 14).

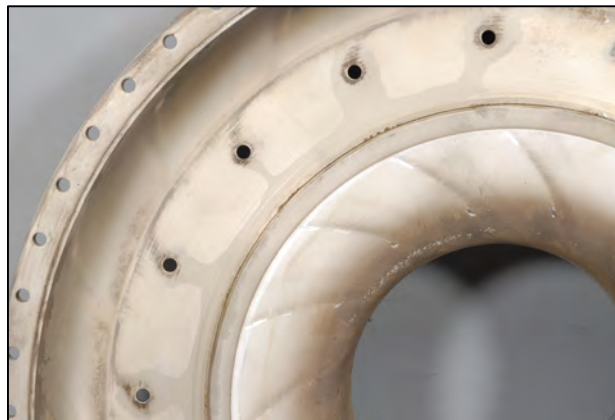
**Figure 16. Second Stage Compressor Shroud**

- Rotational scoring damage (rub) was noted to the second stage compressor impeller shroud at the inducer and exducer areas (Figure 15 & Figure 16) with corresponding scoring to the second stage compressor impeller (Figure 17).
  - Light static contact marks were noted on the second stage compressor impeller shroud. The static marks were on top of the rub indications which evidences that they occurred after impact and the engine had spooled down.

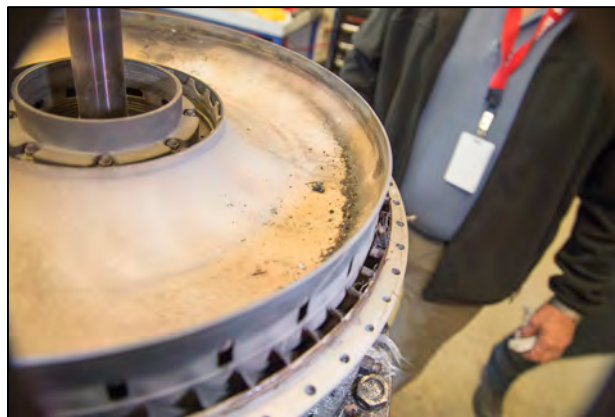
**Figure 22. De-swirl Vane Assembly**

- Ingested debris was noted within the second stage compressor diffuser (Figure 21), de-swirl vane assembly (Figure 22) and combustor liner (Figure 23).

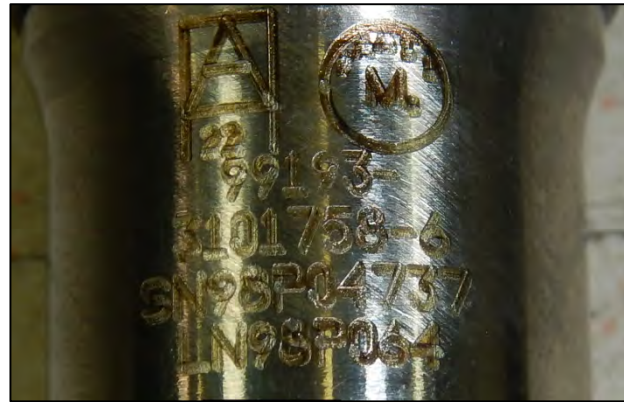
**Figure 36. Torsion Shaft**

The torsion shaft installed in the accident engine was identified with the following markings (Figure 36):

CAGE: 99193-  
Part No.: 3101758-6  
Serial No.: SN98P04737  
Lot No.: LN98P064

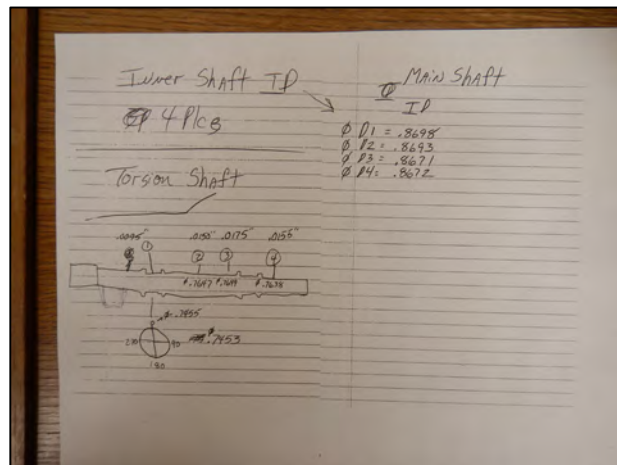
**Figure 40. Inspection Results**

The diameters and runouts of the torsion shaft were measured at ATS in December 2016 (Figure 40). These runouts provided a gross displacement at the measured locations but do not provide the angular displacement, i.e. which direction is the shaft bent at the measured locations. Subsequently, a laser scan of the shaft was performed to quantify the displacement and direction. Those results showed that the displacement was in the same radial direction along the axial length of the shaft and the bend originated at the aft bushing land. The aft bushing land was distressed and heat affected and showed evidence of material removal and redepositing (Figure 41). The separation at the aft end of the torsion shaft was due to torsional overload; no material defects were noted.

No rotational scoring was noted to the shoulders of the torsion shaft aft bushing land. The lack of scoring to the shoulders shows that the torsion shaft did not contact the main shaft after the torsion shaft separated.

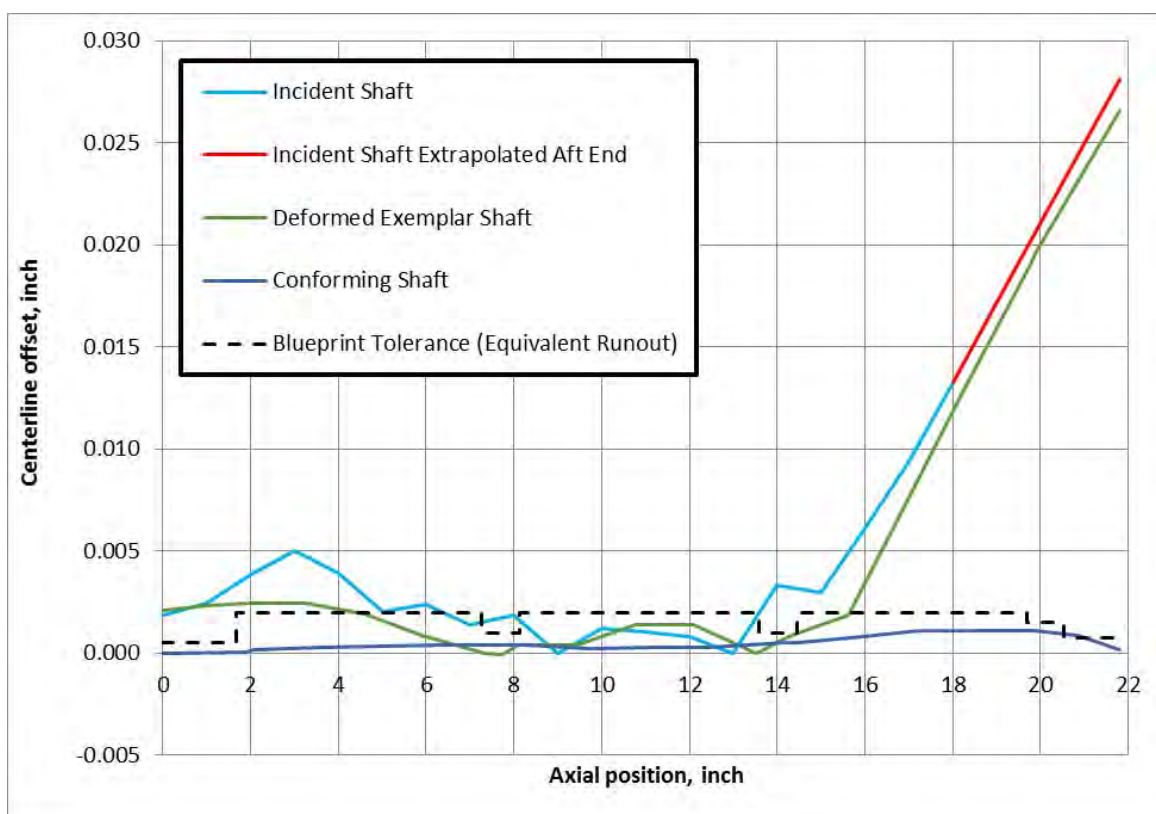
Figure 42 provides a comparison of the geometries of the accident torsion shaft (SN 98P04737), the deformed exemplar torsion shaft (SN 5P-18416) and the conforming torsion shaft (SN 16P87088). Figure 43 shows the test articles.

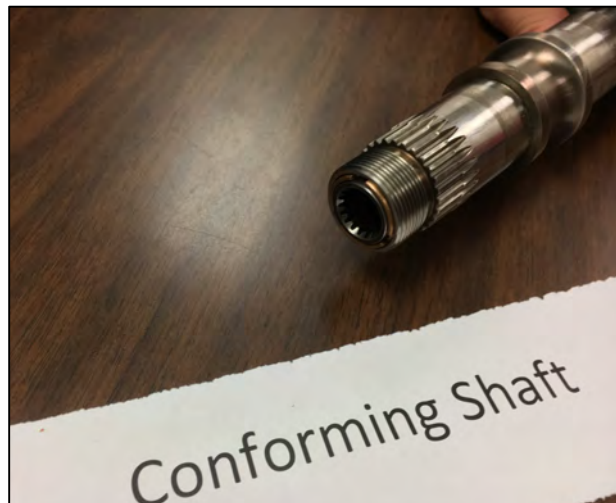
1. The conforming shaft with the bushings installed was installed into the main shaft. Slight resistance was noted as prescribed. The bronze bushing end (forward) of the torsion shaft fully installs (Figure 44).

**Figure 44. Fully Installed Conforming Torsion Shaft with Bushings Installed, End of Bronze Bushing Moved Slightly Forward for Exhibition**

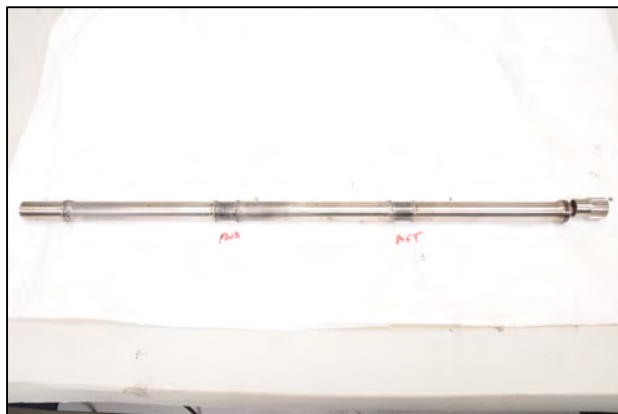
**Figure 50. Salvage Torsion Shaft**

The 3102028 torsion shaft (Figure 49) is a different part number than the accident torsion shaft in question but its function is identical. The shaft was separated forward of the aft splines (Figure 50), consistent with torsional overload. The forward bushing land of the salvage torsion shaft exhibited wear indications (Figure 51).

Inspection of the runouts identified that the shaft was bent and the bend originated at the forward bushing land. This further evidences that the deformation is due to the wear at the land and localized heating. Figure 52 provides a graphical comparison of the bends relative to the locations of the bushing lands for both the salvage and accident torsion shafts.

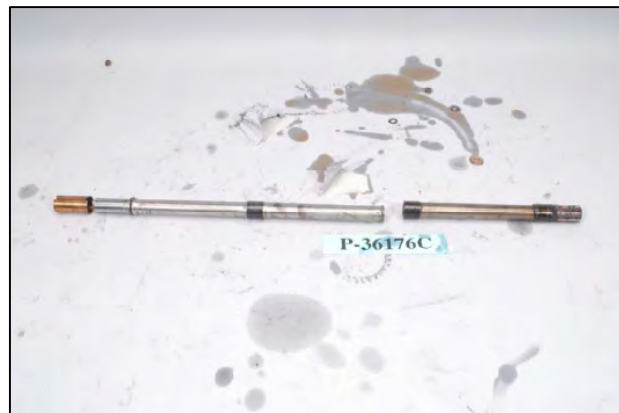
**Figure 55. Left Engine Torsion Shaft**

The examination of the left engine disclosed that the torsion shaft was separated at the aft bushing land, approximately 8.25 inches forward of the aft end of the torsion shaft and forward of the rear Vespel bushing (Figure 55).

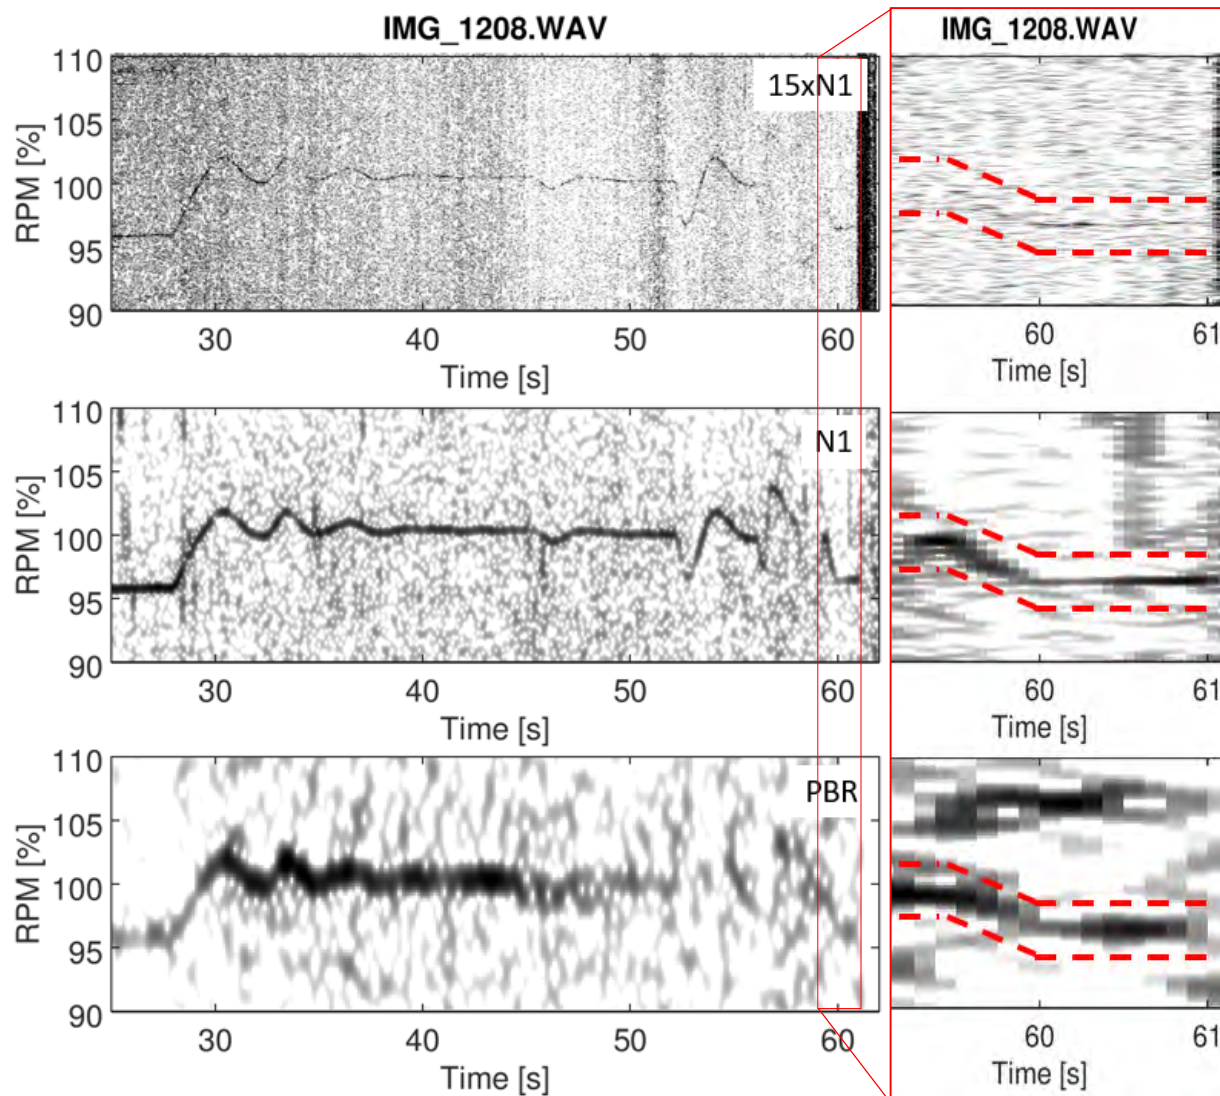
**Figure 63. Engine and Propeller Speeds as a Function of Time, Extracted from the Audio Data**

Around 53 seconds, as the aircraft continues to pitch up and slow, the propeller blade rate frequency becomes difficult to distinguish. However, prior to impact, the engine power section shows a distinct frequency trace throughout the audio portion of the video. At the time of 60 seconds and continuing until impact, all 3 of the frequency traces in [Figure 63](#) show the engine and propeller stabilized at approximately 96% RPM, which evidences that the pilot had reduced the power lever to flight idle.

It is important to note that the power section does not accelerate and stabilize at 104% (OSG set point) at any point during the accident flight. This provides additional evidence that the propeller remained coupled to the engine and the separation of the torsion shaft occurred at impact. Had the torsion shaft separated in flight as opined by plaintiff experts, the sudden reduction in load would have caused the engine power section to accelerate and stabilize at 104% RPM because of the action of the FCU overspeed governor.

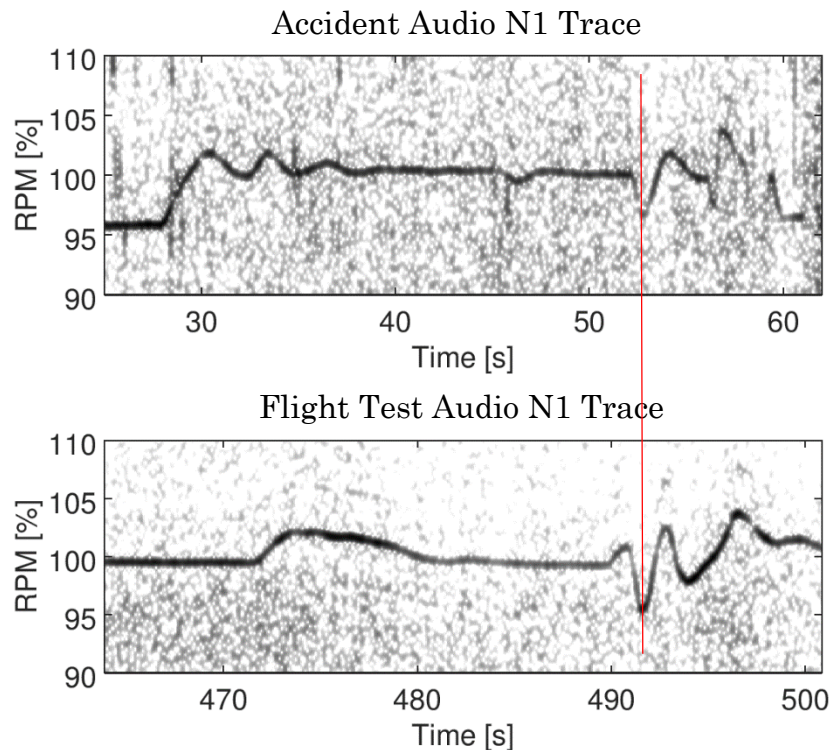
**Figure 65. Accident vs. Flight Test Audio Comparison**

Figure 65 shows a comparison of the engine N1 speed extracted from the accident video with the engine N1 speed extracted from the test flight stall sequence. For clarity, the timeline of the two events have been adjusted to align the speed variations and is denoted by the red line in the figure. The engine speed variations observed in the accident video during the climb and stall ( $t=52s$  to  $61s$ ) are remarkably similar to the engine speed variations observed in the flight test climb and stall sequence ( $t=490s$  to  $499s$ ), both in terms of shape and in magnitude. This

suggests that the engine speed variations observed in the accident recording were normal and a response to commanded pilot inputs as captured on the flight test video recording.

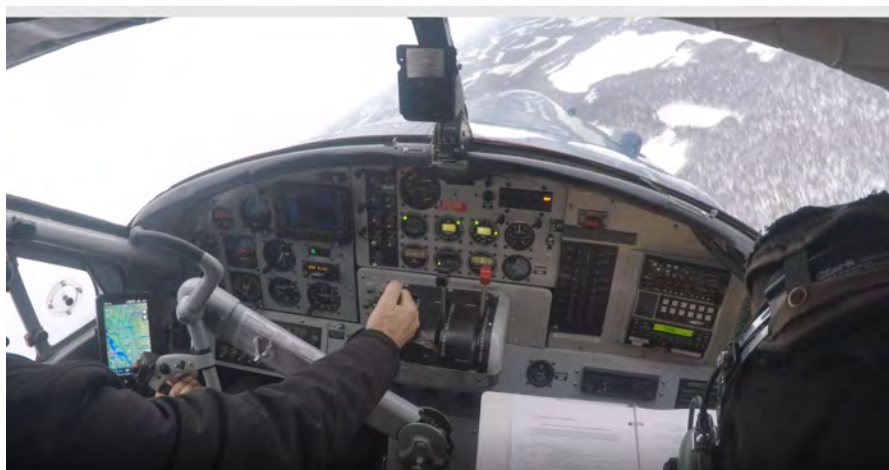
**Figure 66. Horizon Reference after Stall during Flight Test**

The flight test also disclosed that when performing a stall *with* power, the aircraft breaks right, rolls approximately 30 degrees and pitches down. [Figure 66](#) provides a reference to the horizon following the break of the right wing.

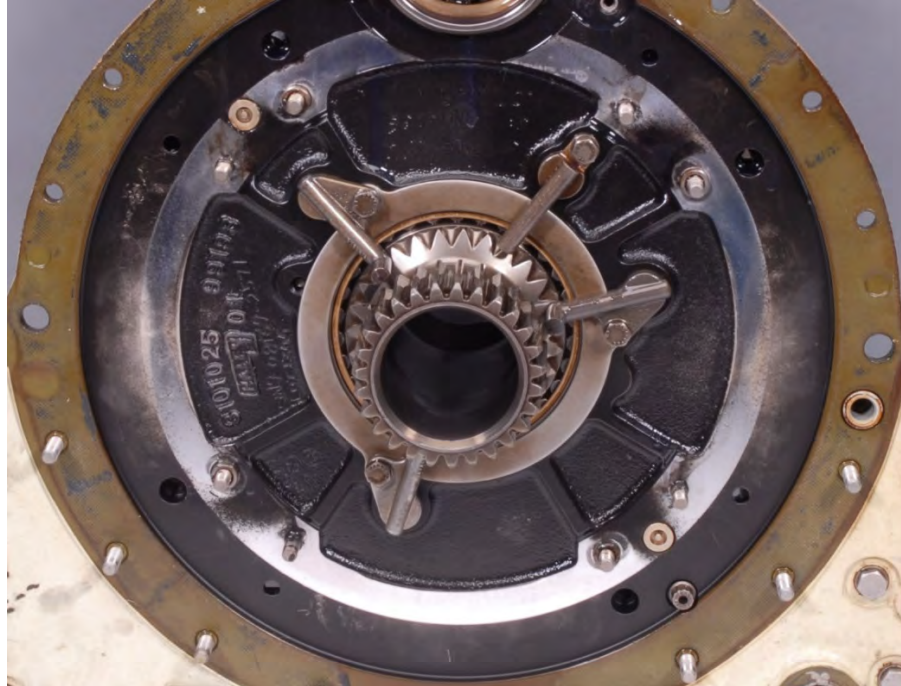
**Figure 67. Ring Gear Support Mount Dowels**

4. Medicine Lake, Montana (NTSB ID WPR14LA198<sup>15</sup>) – The torsional overload separation of the torsion shaft is consistent with a propeller strike upon impact with terrain. The wear damage to the torsion shaft bushing land is consistent with the continued operation of the power section after the propeller strike and separation of the torsion shaft. Also, the ring gear support mount dowels are displaced counter-clockwise (Figure 67), which provides evidence of a coupled engine at impact.

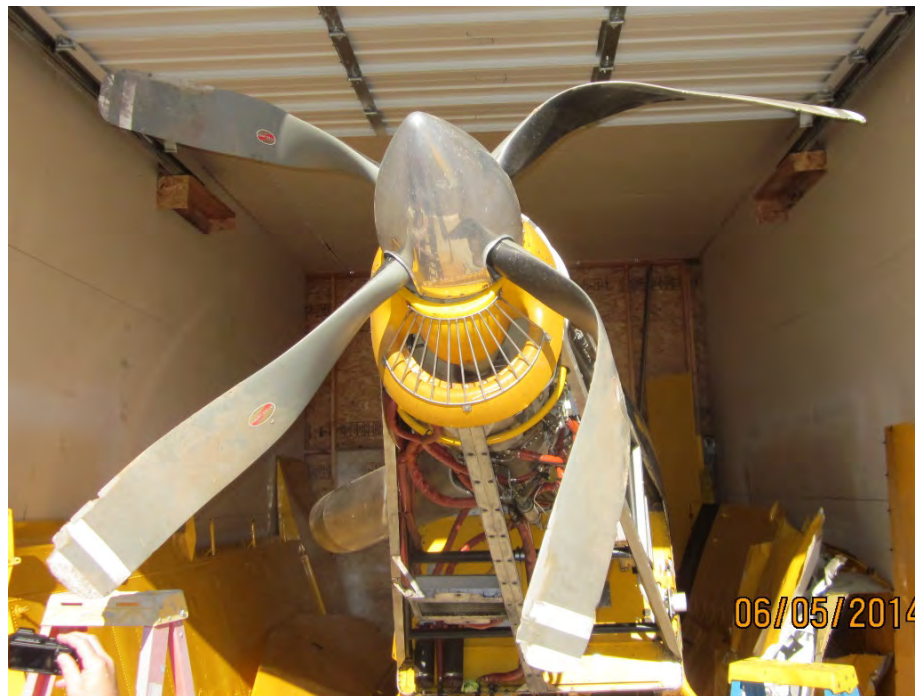
**Figure 68. Medicine Lake Propeller**

Additionally, photos of the propeller show leading edge nicks and gouges and forward and aft propeller blade bending (Figure 68). The damage is consistent with an operating engine and coupled propeller impacting terrain.

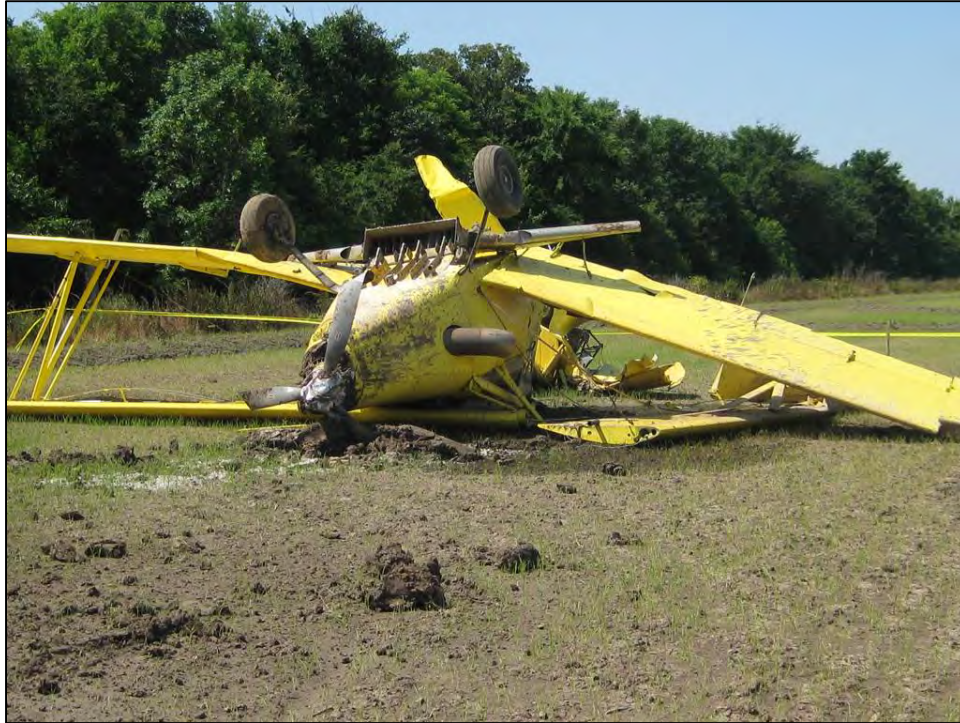
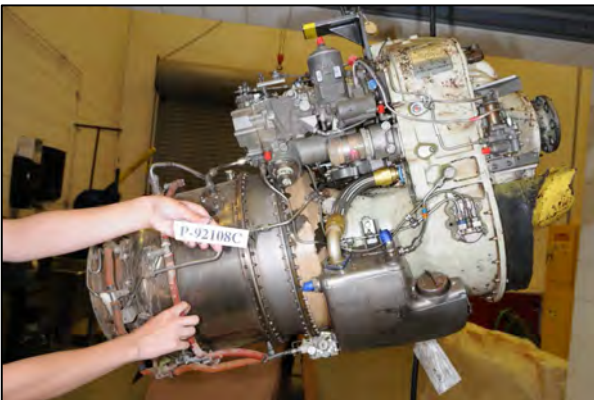
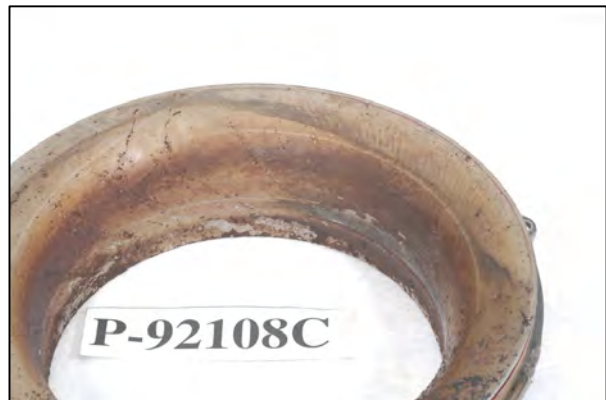
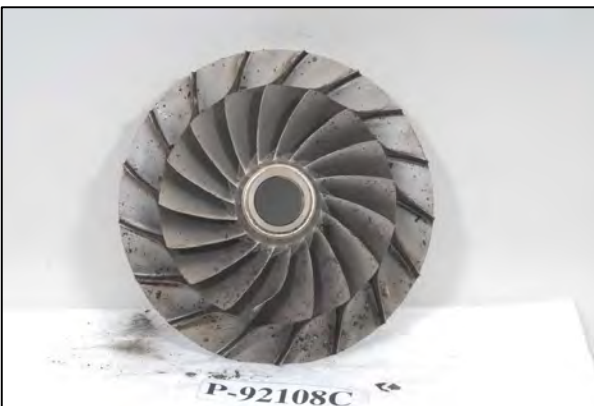
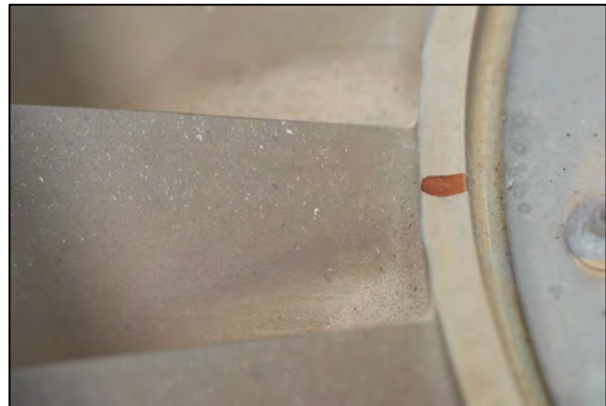
- Delaplaine, Arkansas (NTSB ID: CEN15LA259<sup>18</sup>) – The teardown and examination of the engine, S/N P-92108C, revealed that the type and degree of damage was indicative of an engine that was rotating and operating at the time of impact. No pre-existing condition was found that would have prevented normal operation. The engine was generally intact, displayed compressor shroud rubs and metal spray deposits on the turbine stators and rotors. The torsion shaft was separated ~1.2” from the aft end. Representative photos are provided in [Figure 69 - Figure 73](#).

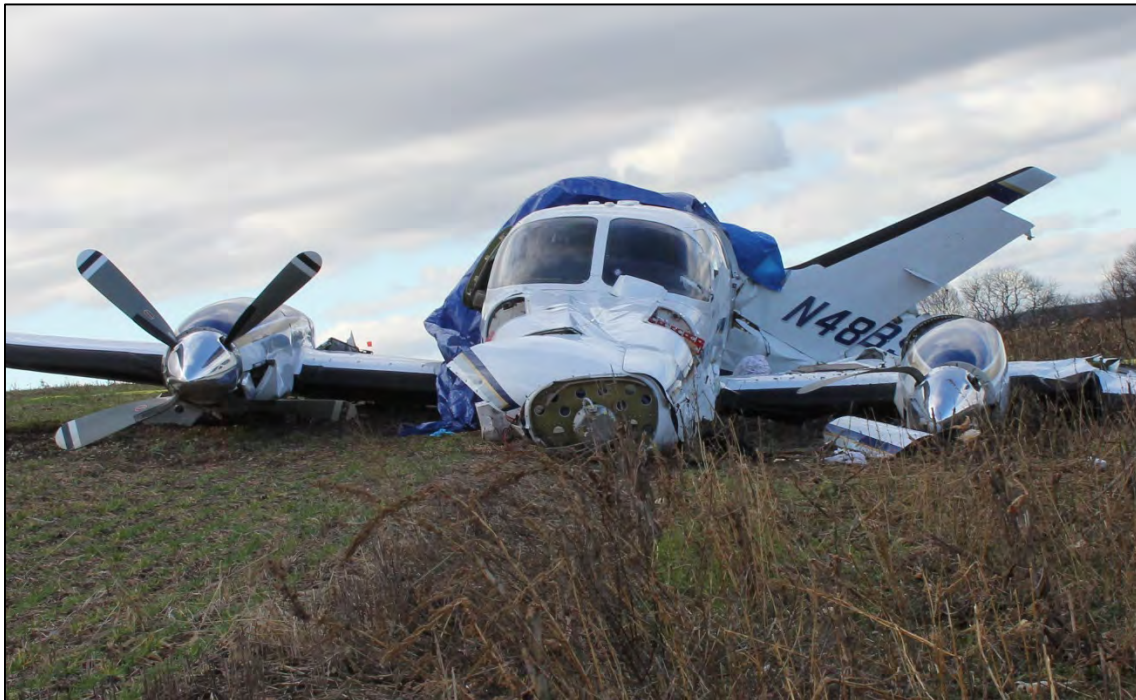
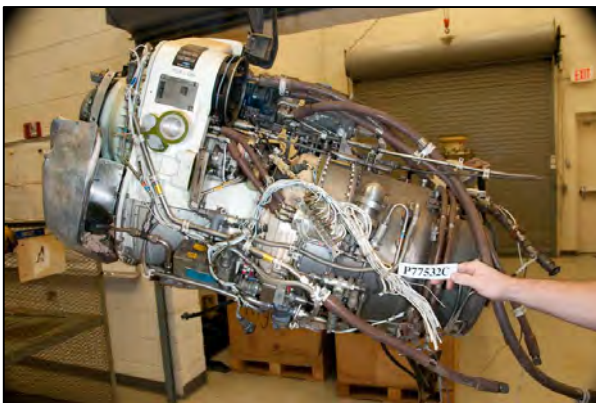
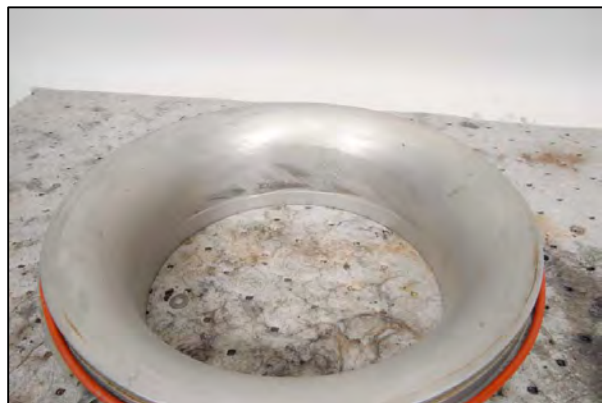
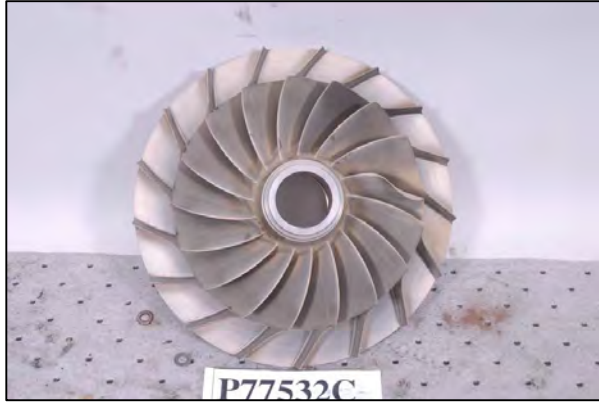
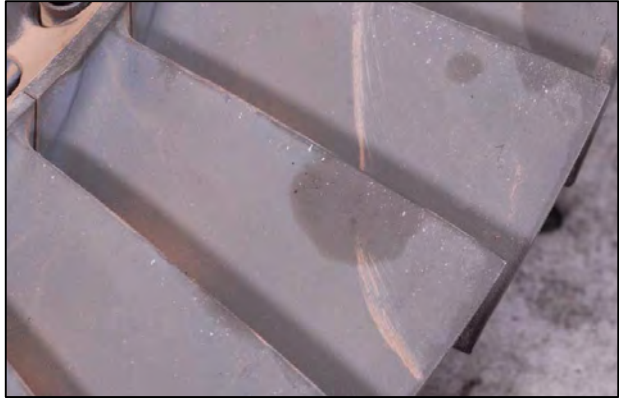
- Nashville, Pennsylvania (NTSB ID: ERA12FA120<sup>19</sup>) – The teardown and examination of the left engine, S/N P-77532C, revealed that the type and degree of damage was indicative of an engine that was under power and operating at the time of impact. No preexisting condition was found that would have prevented normal operation. The engine was generally intact, displayed compressor shroud rubs and metal spray deposits on the turbine stators and rotors. The torsion shaft was separated forward of the aft splines. Representative photos are provided in Figure 74 - Figure 78.

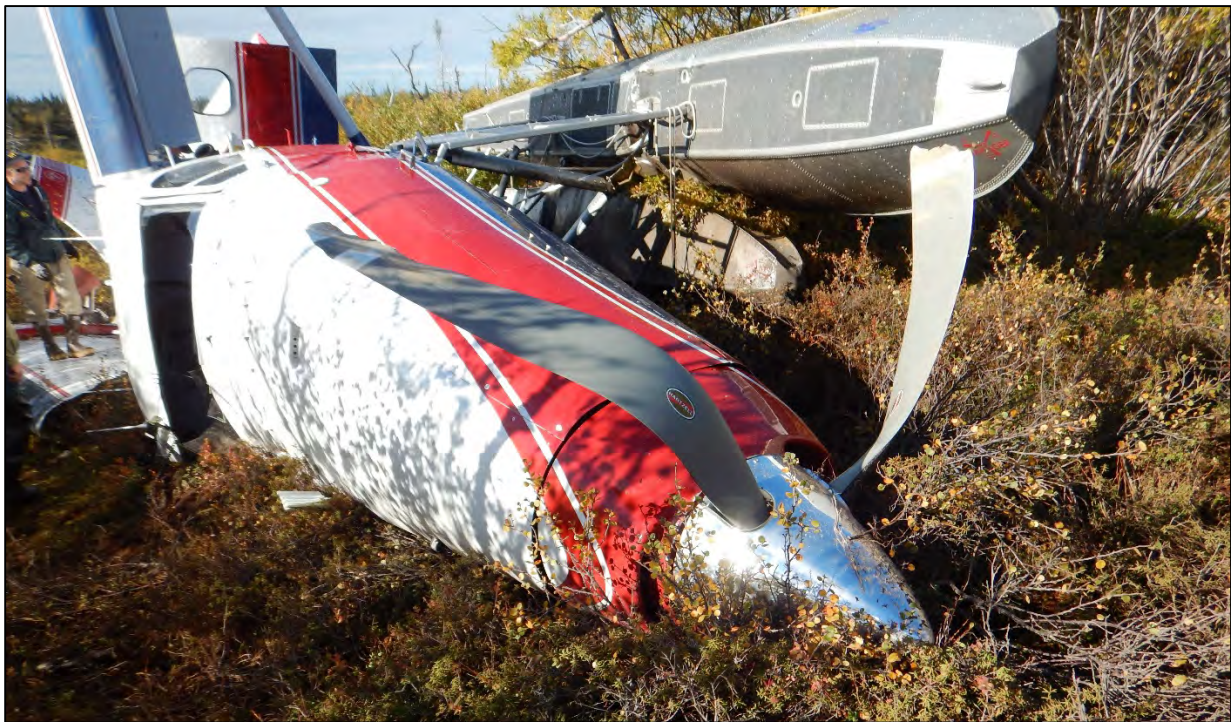
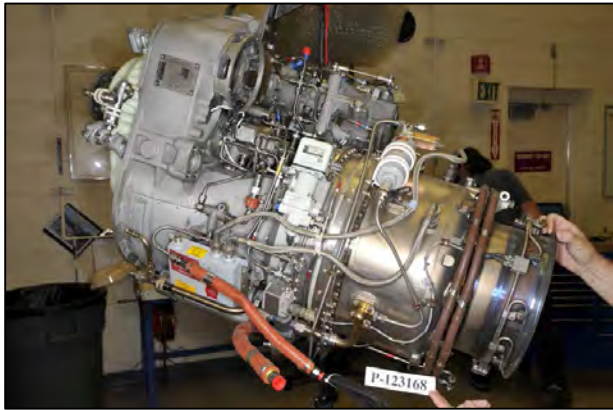
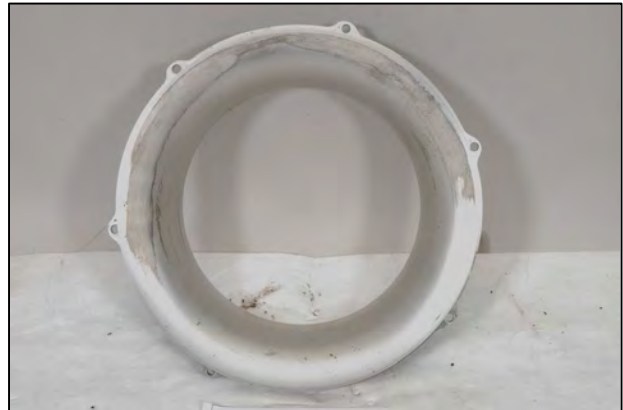
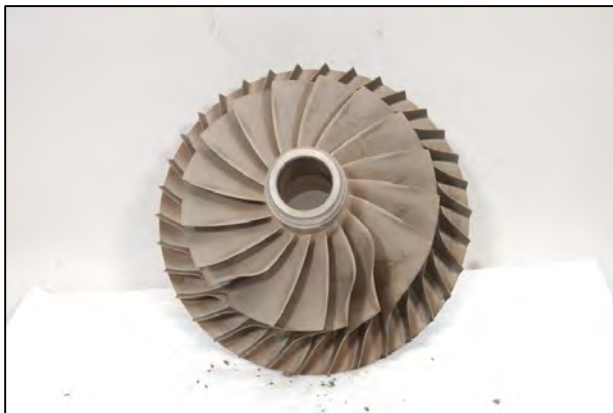
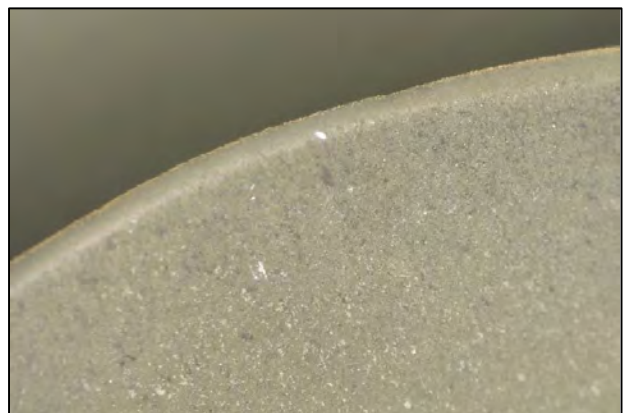
- Iliamna, Alaska (NTSB ID: ANC15FA071<sup>20</sup>) – The teardown and examination of the engine, S/N P123168, revealed that the type and degree of damage was indicative of an engine that was under power and operating at the time of impact. No pre-existing condition was found that would have prevented normal operation. The engine was generally intact, displayed compressor shroud rubs and metal spray deposits on the turbine stators and rotors. Representative photos are provided in [Figure 79 - Figure 83](#).

The preceding three accidents show that low speed/low energy crashes can cause minimal contact between the rotating and stationary structures in the engine, which results in minimal rub signatures.

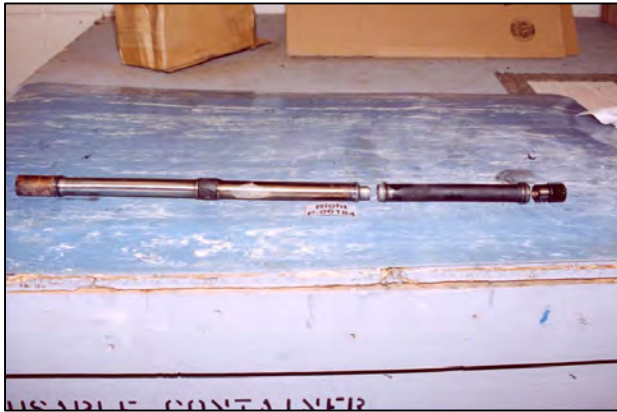
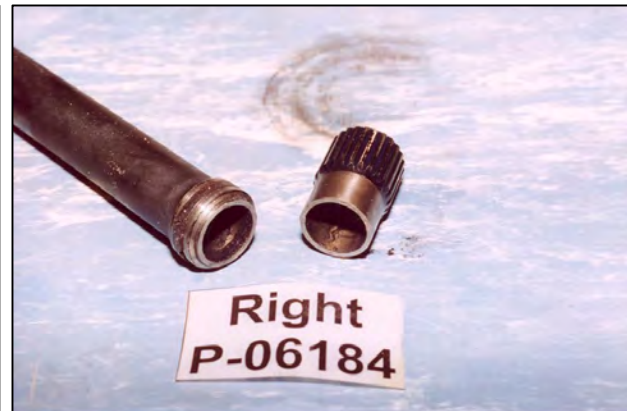
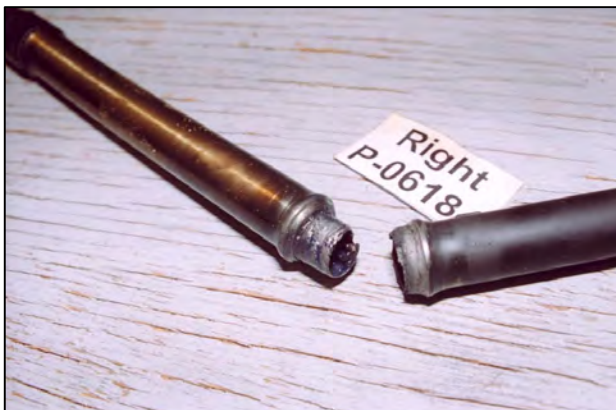
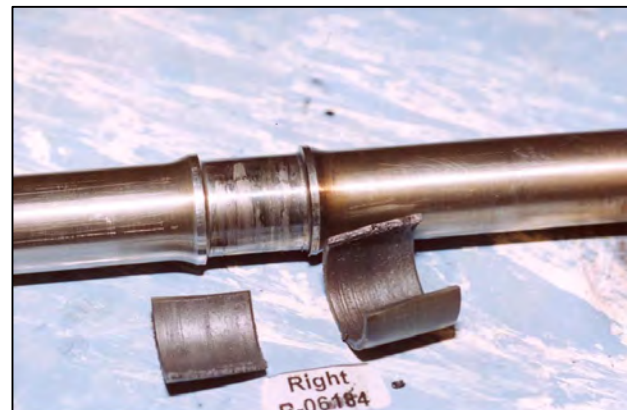
the aft bushing location due to the relative rotation and rotational scoring between the torsion shaft and the Vespel bushing. The forward bushing land also exhibited rotational scoring and wear. Similar to the accident engine in question, the power section continued to operate for a period of time after the propeller strike. Representative photos are provided in Figure 84 - Figure 87.

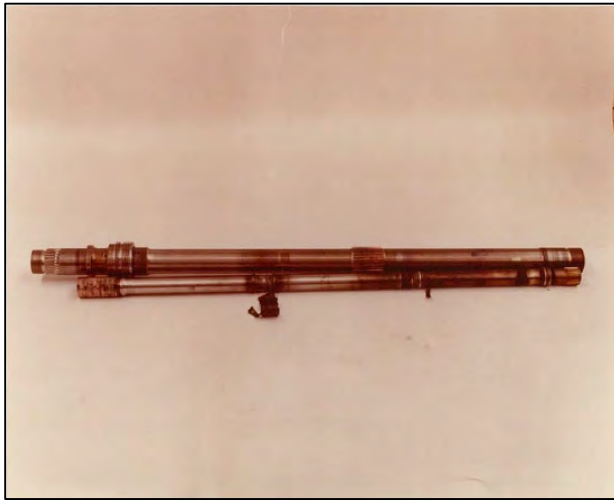
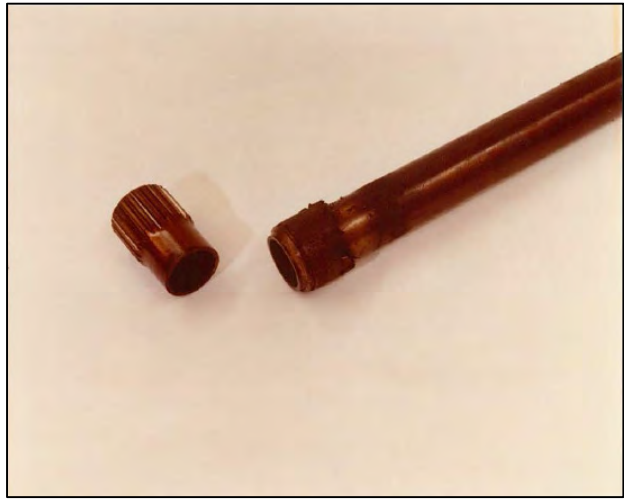
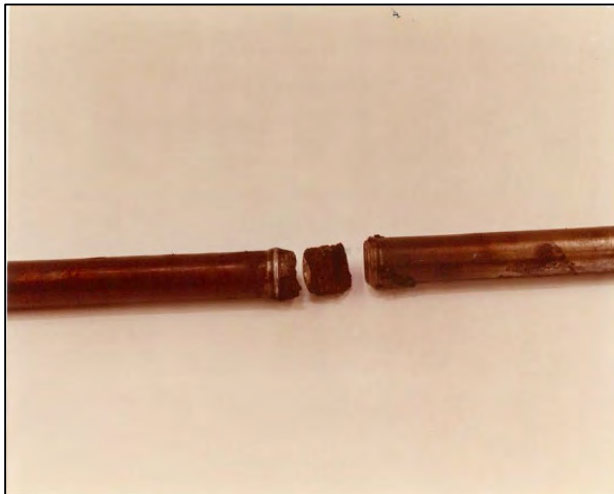
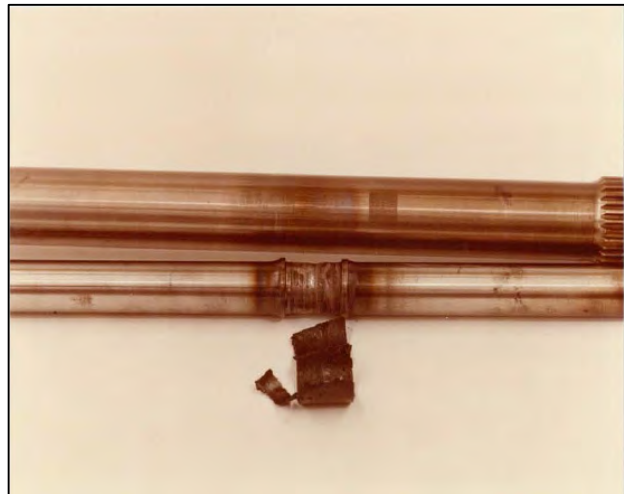
- Goldsboro, Maryland (NTSB ID: IAD80FA019<sup>22</sup>) – The torsion shaft from the right engine (P-06051) separated just forward of the aft splines consistent with torsional overload. The torsion shaft also separated at the aft bushing location due to the relative rotation and rotational scoring between the torsion shaft and the Vespel bushing. The forward bushing land also exhibited rotational scoring and wear. Similar to the accident engine in question, the power section continued

to operate for a period of time after the propeller strike separated the torsion shaft. Representative photos are provided in [Figure 88 - Figure 91](#).

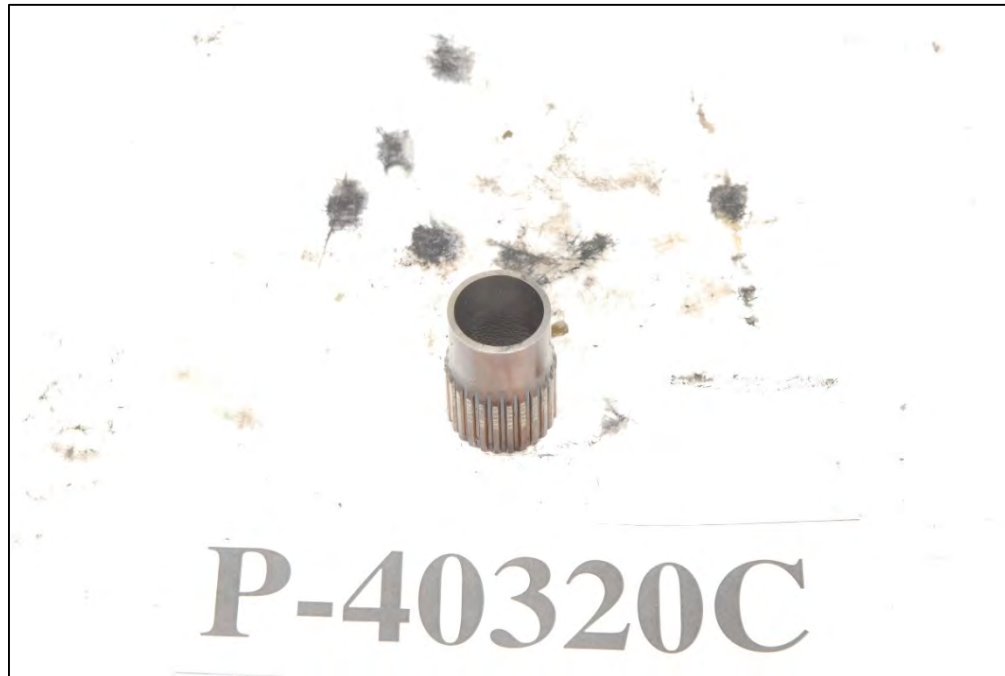
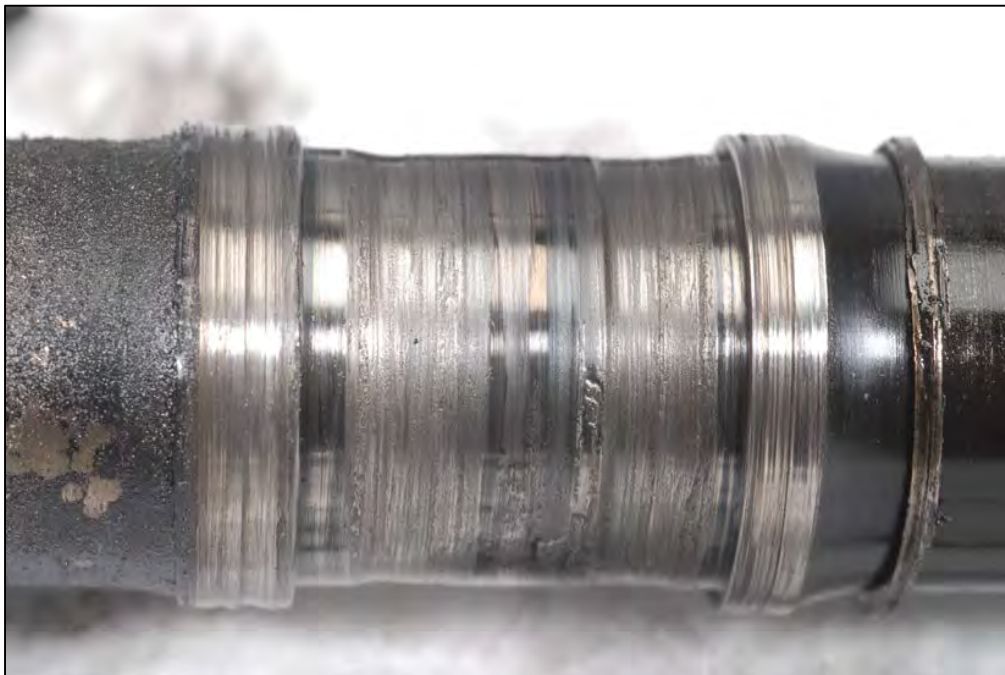
- Medicine Lake, Montana (NTSB ID: WPR14LA198<sup>23</sup>) – The torsion shaft from the engine (P-40320C) separated just forward of the aft splines consistent with torsional overload. The forward bushing land and shoulders exhibited significant rotational scoring and wear due to the relative rotation between the torsion shaft and the Vespel bushing and main shaft. Similar to the accident engine in question, the power

section continued to operate for a period of time after the propeller strike separated the torsion shaft. Representative photos are provided in [Figure 92 - Figure 93](#).
